# **Intel<sup>®</sup> Mobile Pentium<sup>®</sup> II Processor Specification Update**

Release Date: March 2000

Order Number: 243887-019

The Mobile Pentium<sup>®</sup> II processor may contain design defects or errors known as errata which may cause the product to deviate from published specifications. Current characterized errata are documented in this Specification Update.

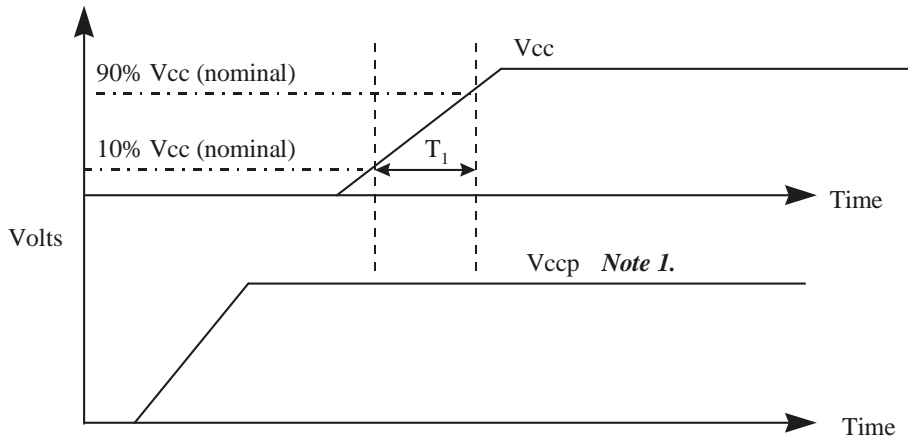
**Figure 1.  $V_{CC}/V_{CCP}$  Timing Requirements (Mobile)**

**Problem:** The processor uses the PWRGOOD signal to ensure that no voltage sequencing issues arise; no pin assertions should cause the processor to change its behavior until this signal is asserted, when all power supplies and clocks to the processor are valid and stable. However, if  $V_{CC}$  ramps up before  $V_{CCP}$ , it will cause the processor to enter an invalid state.

**Implication:** If this erratum occurs, the system may boot normally however, the L2 cache may not be initialized.

**Workaround:** For Mobile Pentium II processors, ensure that  $V_{CC}$  ramps after or with the L2 cache IO voltage ( $V_{CCP}$ ). If  $V_{CCP}$  ramps after the  $V_{CC}$ , a delay circuit can be placed on the core  $V_{CC}$  to ensure that  $V_{CC}$  ramps at the same time or after  $V_{CCP}$  as shown below in Figure 1.

Symbol	Parameter	Min	Max	Notes
$T_1$	$V_{CC}$ Ramp Time	200 $\mu$ Sec		Measured between 10% $V_{CC}$ (nom) to 90% $V_{CC}$ (nom)
<b>Note 1:</b> $V_{CCP}$ must be greater than $V_{CC}$ during the interval in which $V_{CC}$ rises from 20% $V_{CC}$ to 80% $V_{CC}$ .

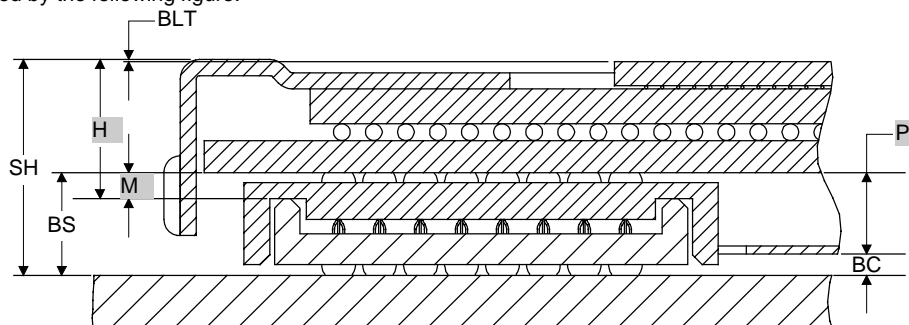
**Figure 5.6. Cross Sectional View with Vertical Dimensions**

### B1. Misabeled Vertical Dimension Parameters

Figure 5.6 in the *Mobile Pentium® II Processor at 233 MHz, 266 MHz, and 300 MHz* datasheet should be replaced by the following figure:
